# Fatigue Failures of Vehicle Components

Vatroslav Grubisic

# The Automobile Industry in Japan and Germany- Strategic Challenges and New Perspectives in the Age of Globalization

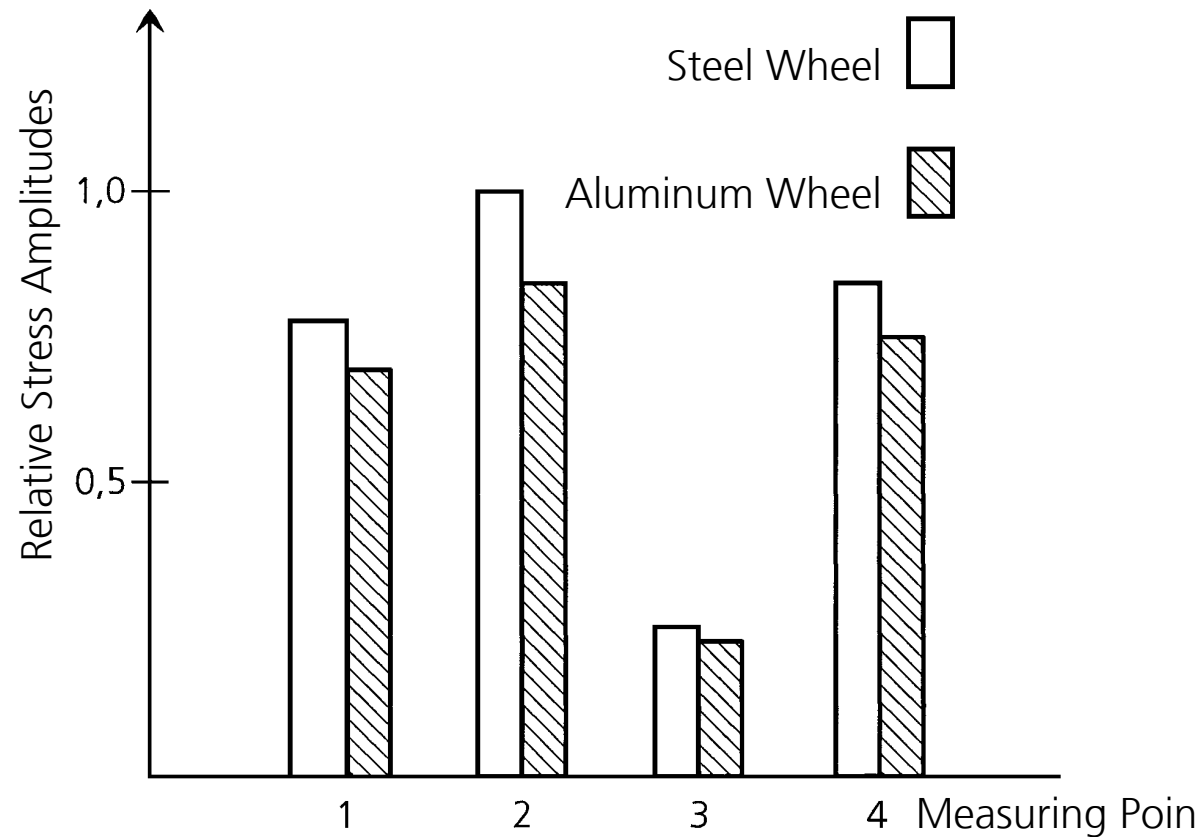
DIA 7317e

# Influence of Wheel Design on Hub Stresses

## Load Condition: Cornering

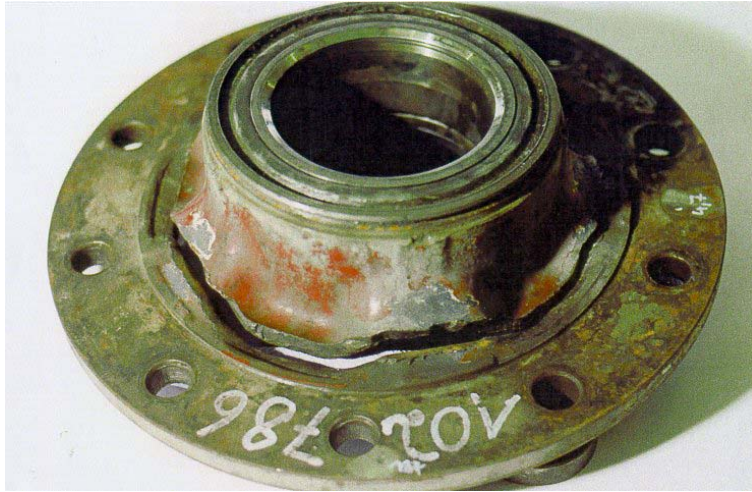
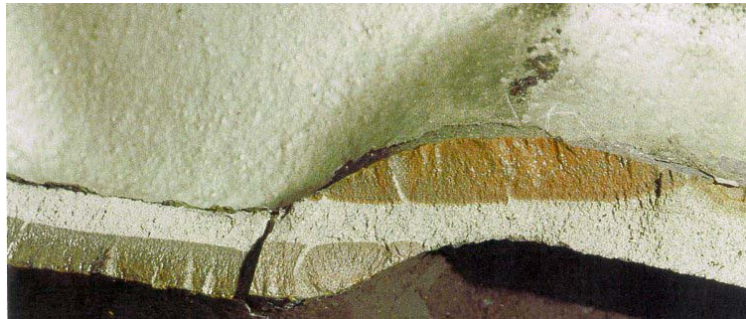
# Fatigue Fractures on Trailer Hubs

Wheel: 22.5 x 11.75; Tyre: 385/65R22.5 Bridgestone; Wheel rated load:  $F_{z,stat} = 55 \text{ kN}$

Fracture after  $\approx 200\,000 \text{ km}$  Service usage

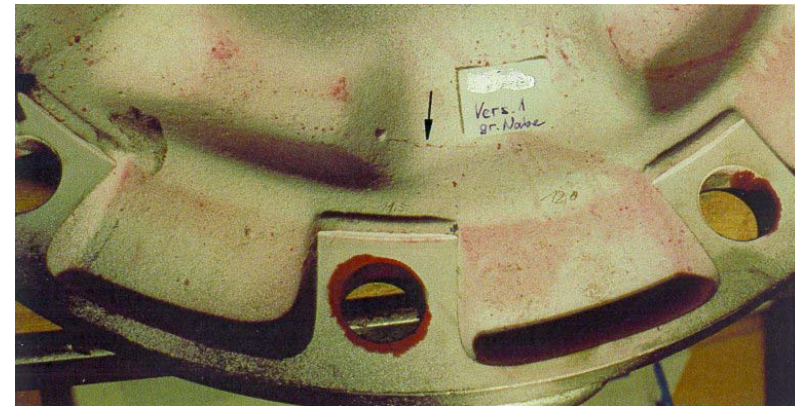
Fracture in Biaxial Wheel/Hub Test Facility  
Load Programme „Eurocycle“  
Test Life  $\approx 7\,000 \text{ km}$

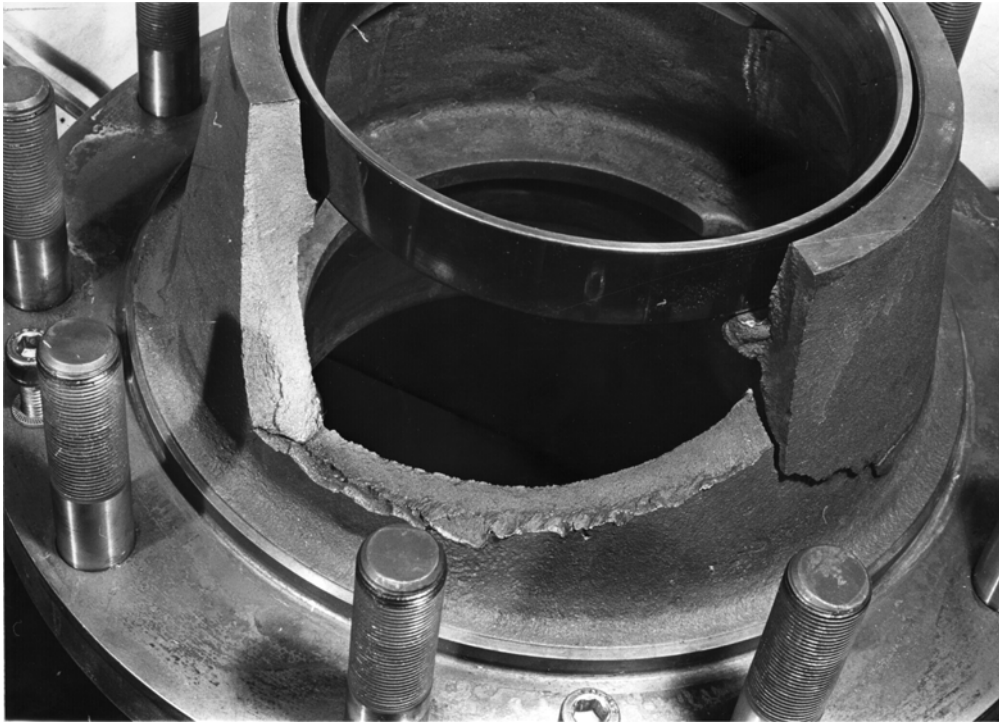
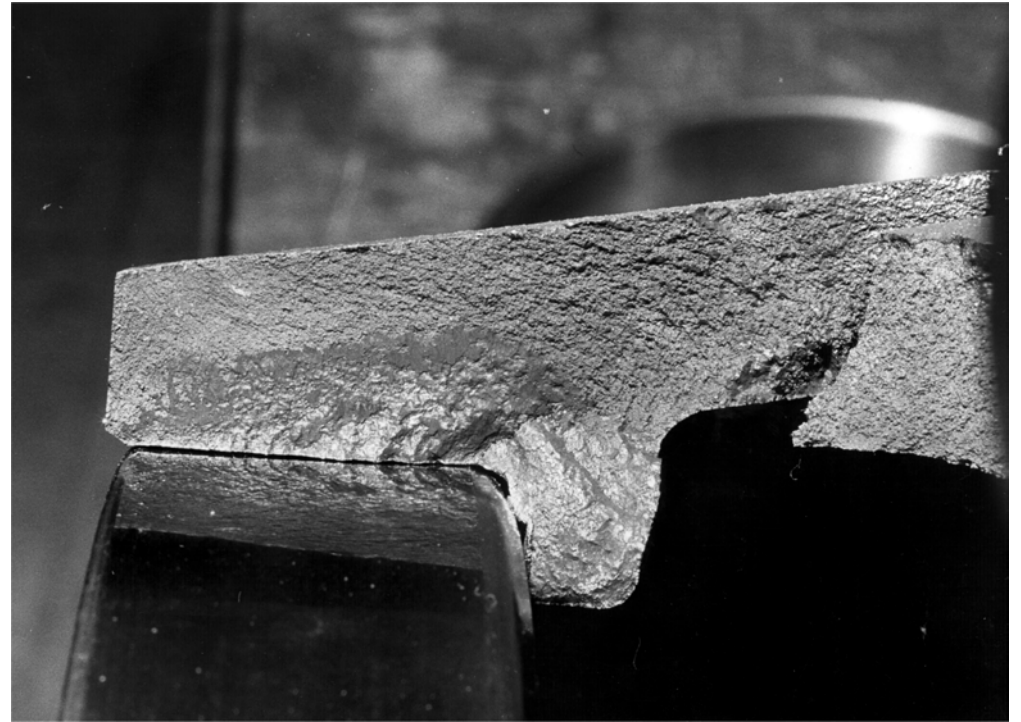
DIA 3885e

# Fatigue Fracture on Cast Hubs for Commercial Vehicles (Nodular Iron GGG 50)

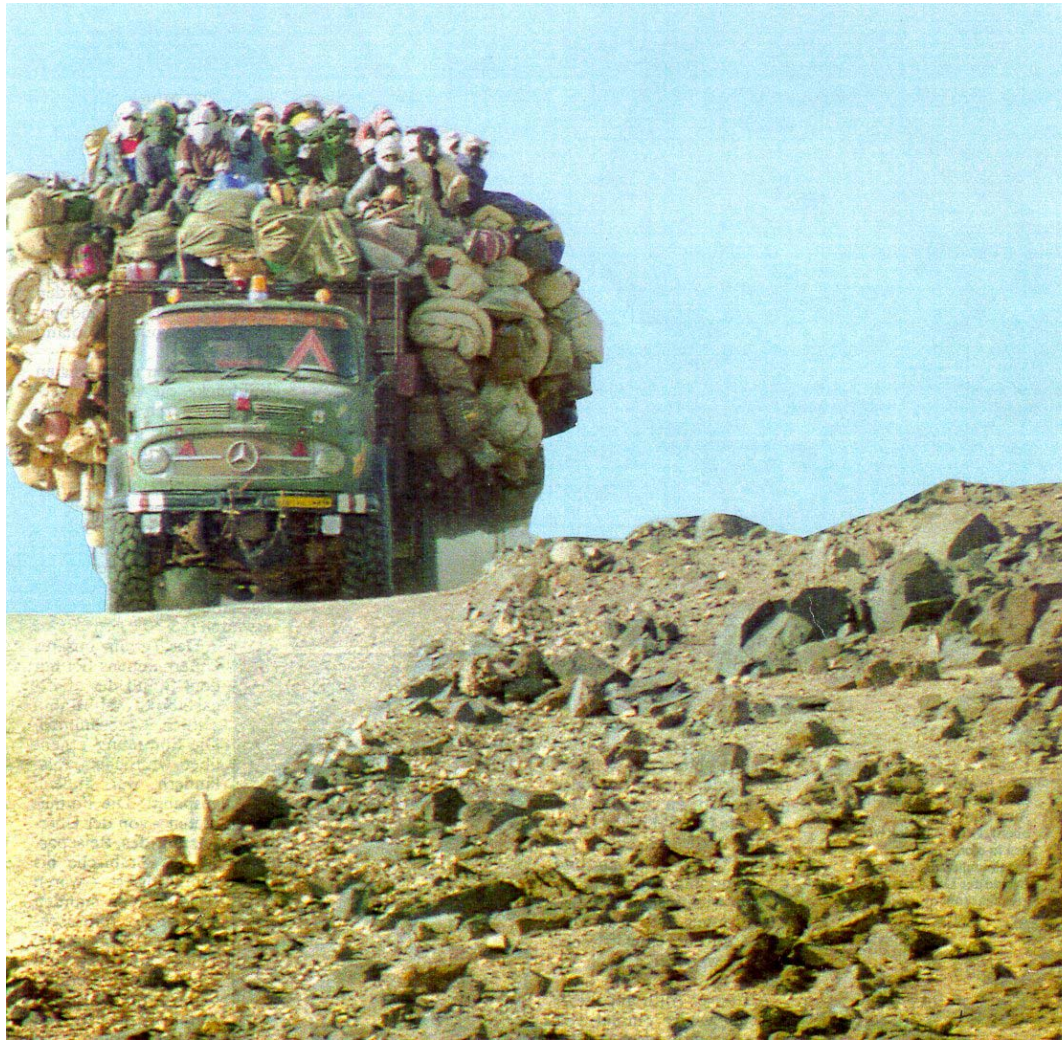
# Truck Overloaded

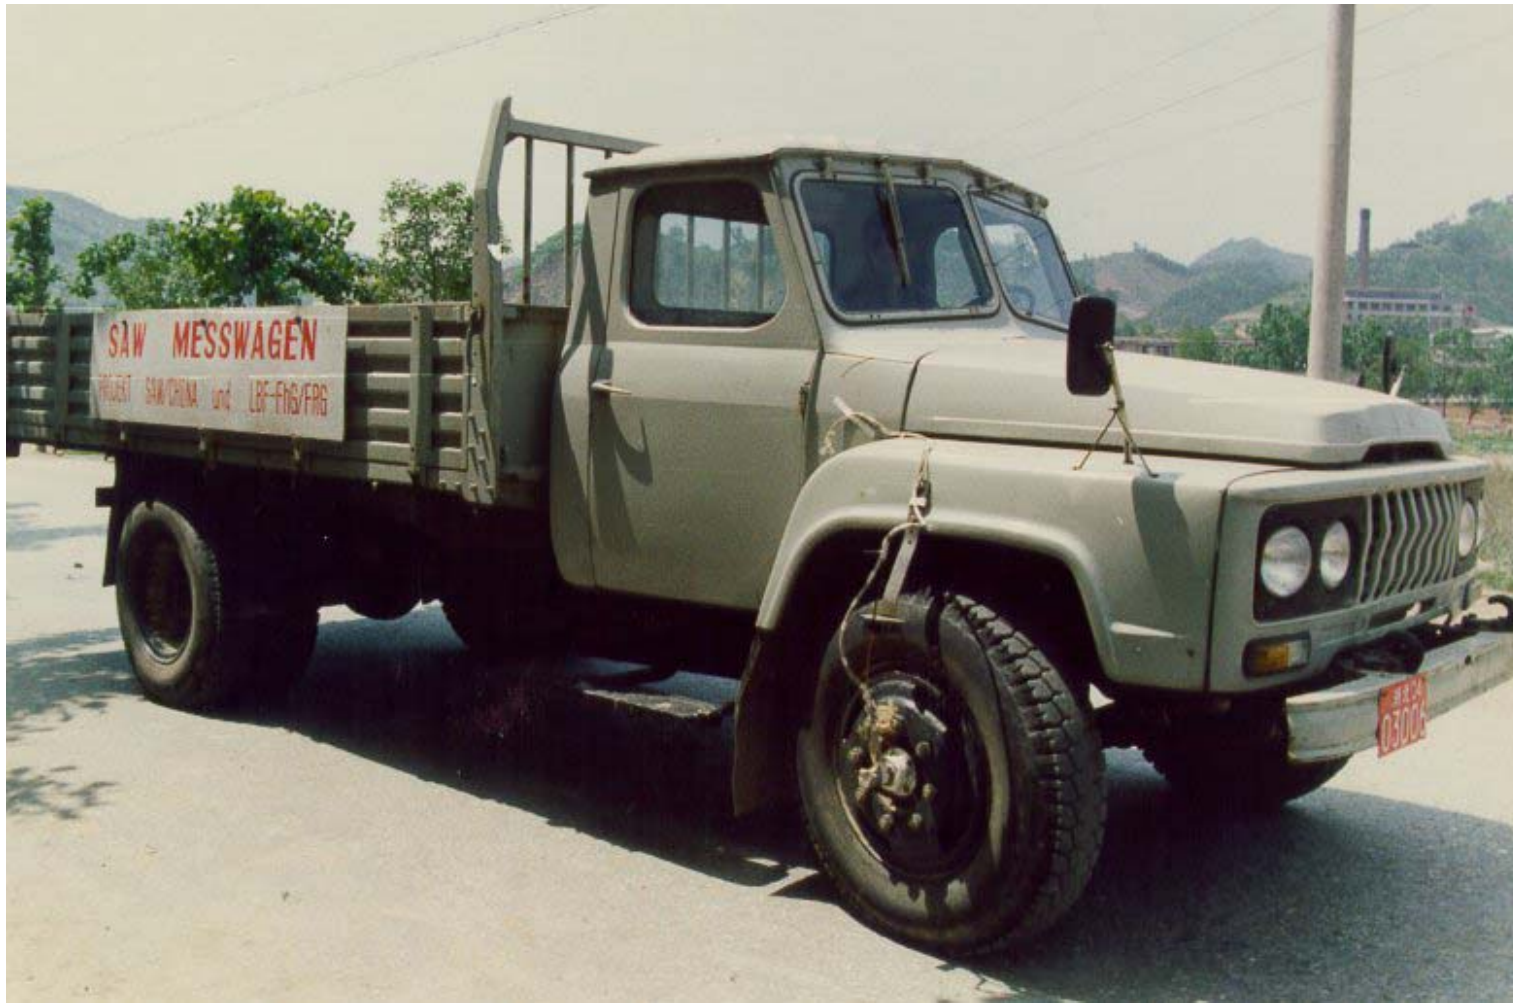
# Measuring Vehicle

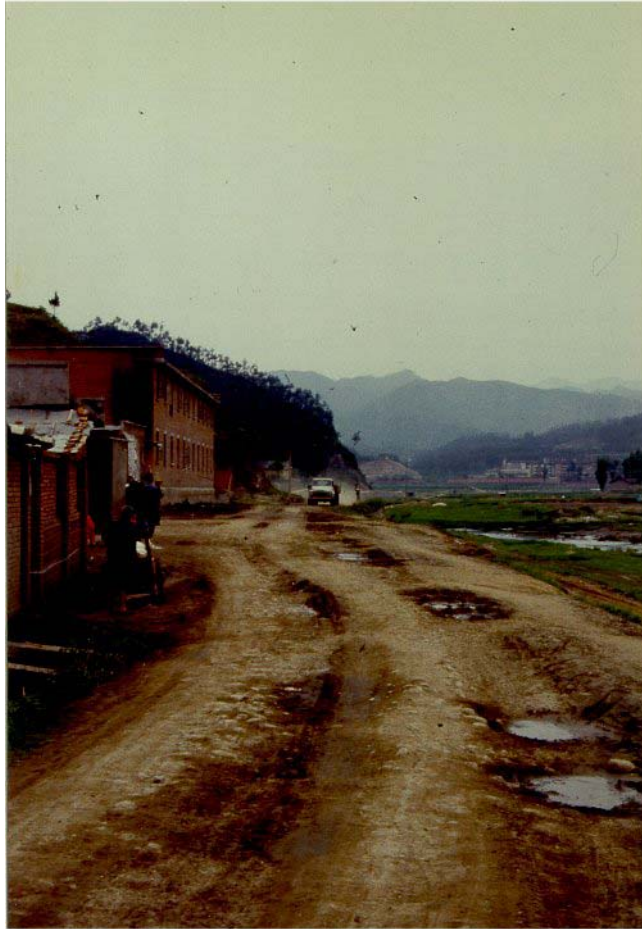
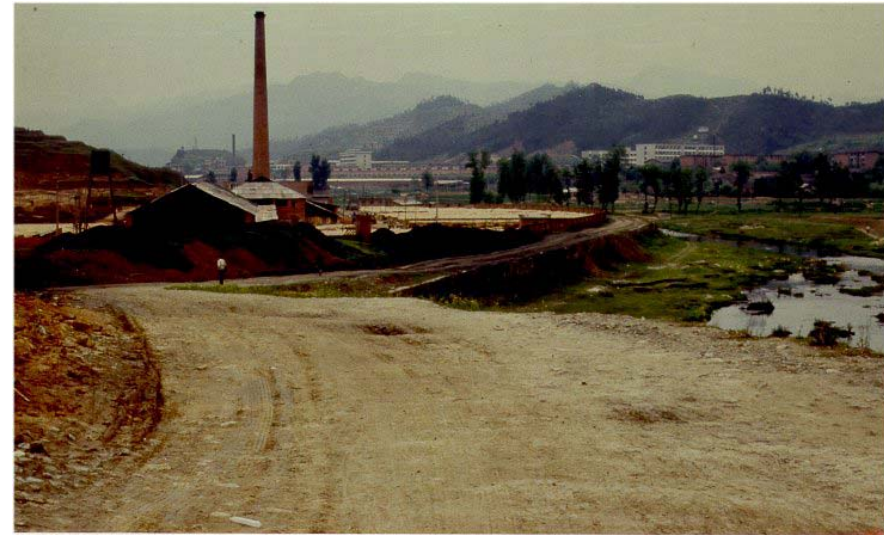
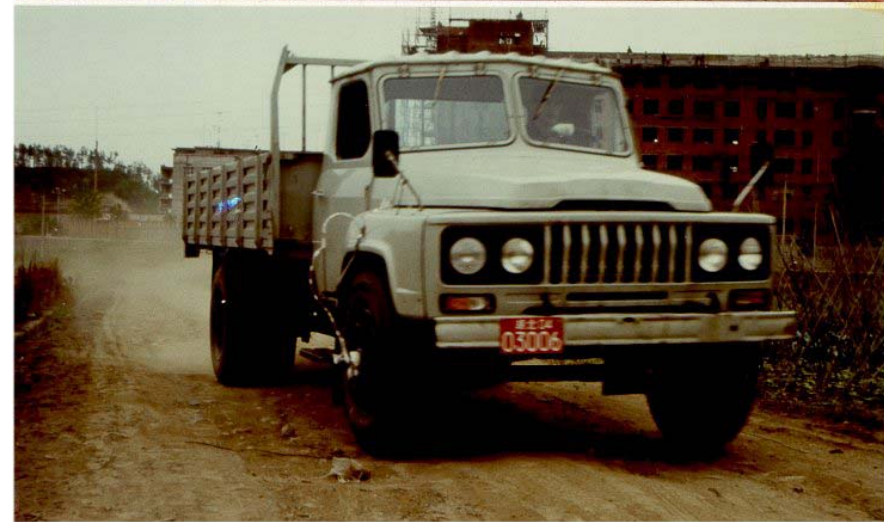
# Pothole Test Track *MAO JIAN*

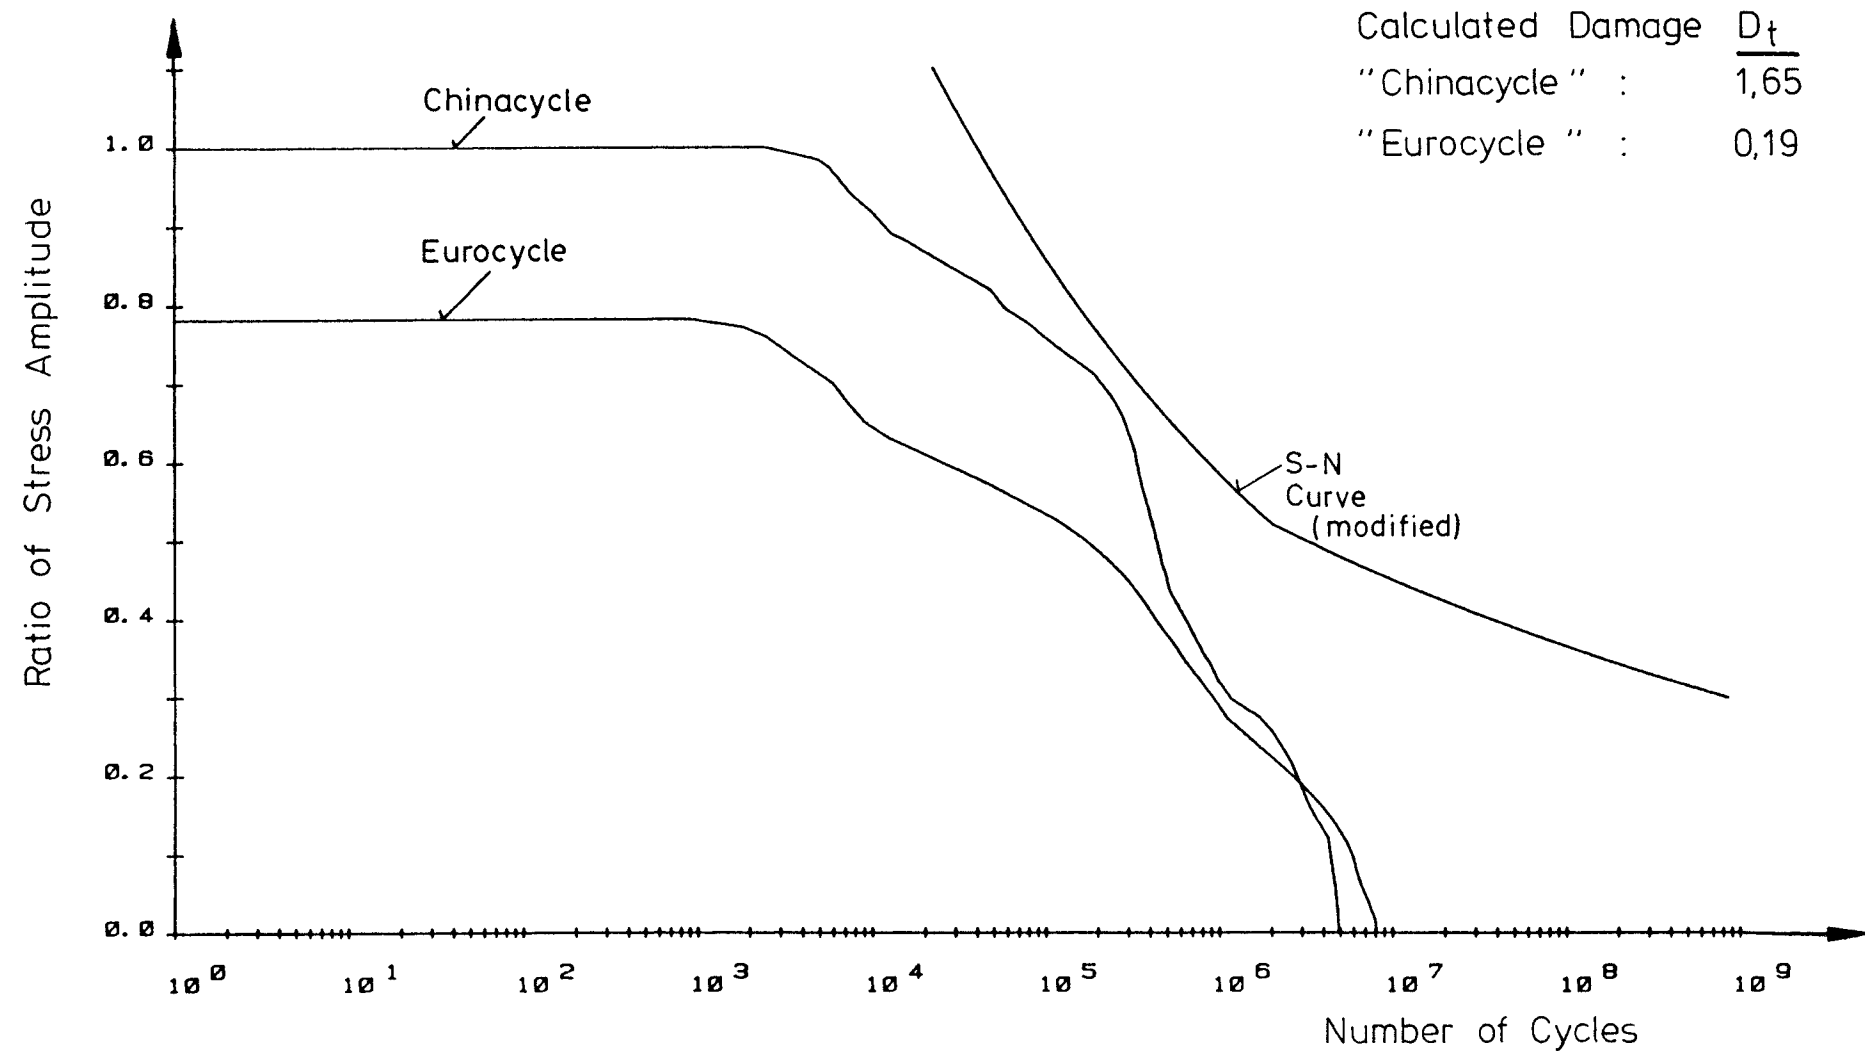
# Comparison of Test Spectra ( $L_t = 15\,000\text{ km}$ ) Hub, Area Gage 3

# Influence of Design Spectra on Required Design Modifications

Damage Relation:  $D_{\text{China}} \approx 5 D_{\text{Europe}}$

Design Life Relation:  $L_{\text{China}} \approx 1/5 L_{\text{Europe}}$

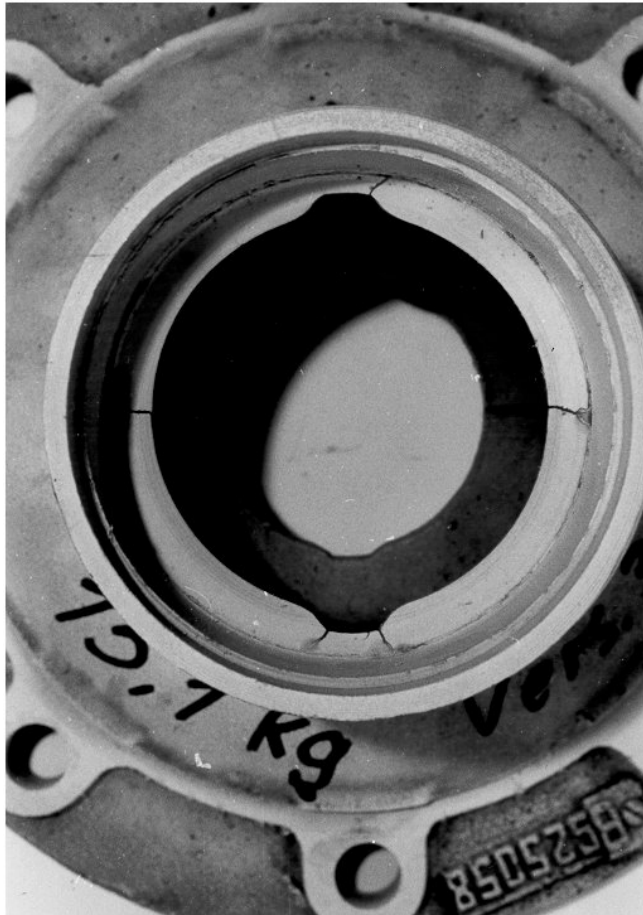
# Proof Test in Biaxial Test Facility Load Program *CHINACYCLE*

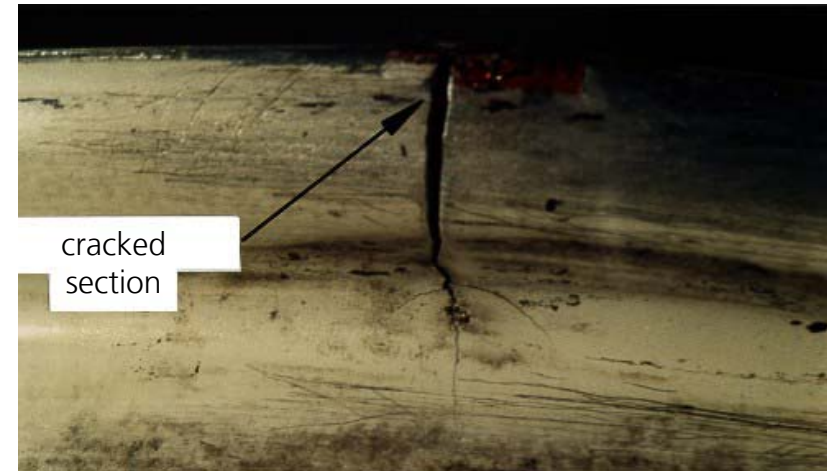
# Procedure for Pre-Loading of Wheels for Durability Approval

Static Pre-Loading:

Vertical Force:  $F_v = 2,5 \cdot F_{v,stat}$

Tyre pressure:  $p_l = 0,6 \cdot p_{l,n}$

Half tyre width (inside section)

Obstacle radius  $r = 12 \text{ cm}$

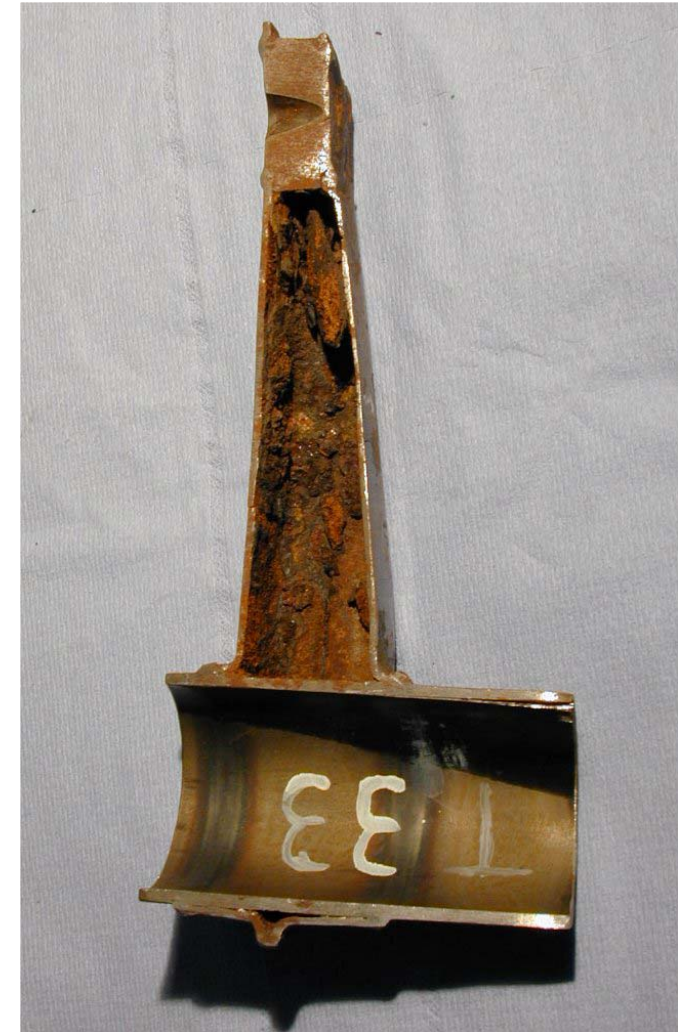
DIA 7337e

# Steering-Knuckle Arm

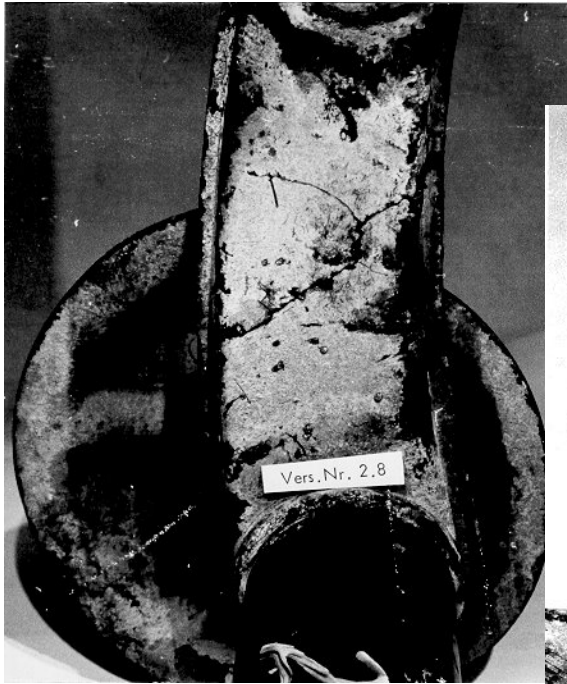
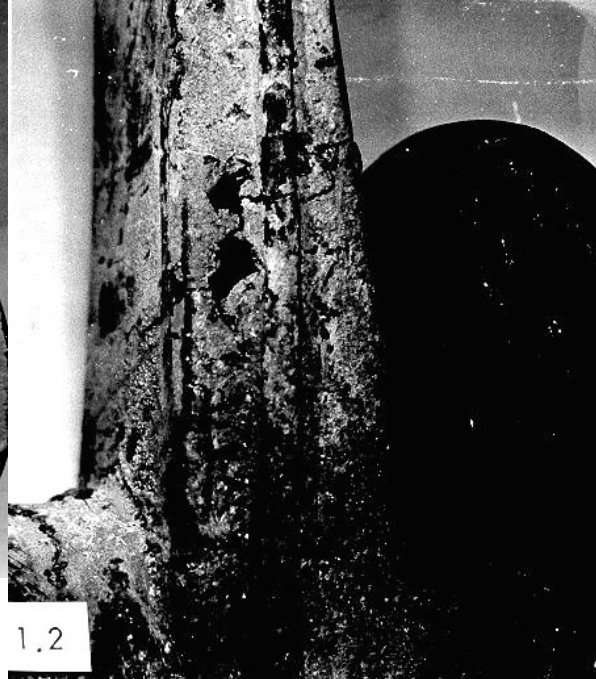
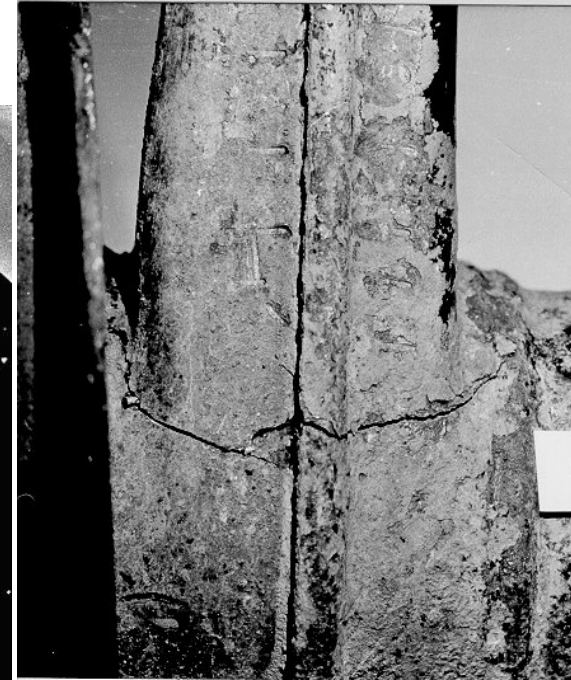
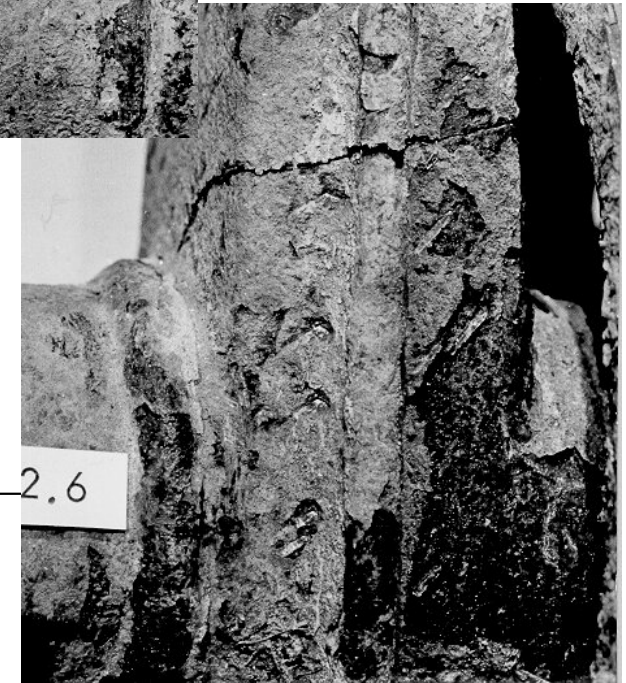
DIA 7338e

# Typical Cracks on Steering-Knuckle Arms

**corroded**

**rust out**

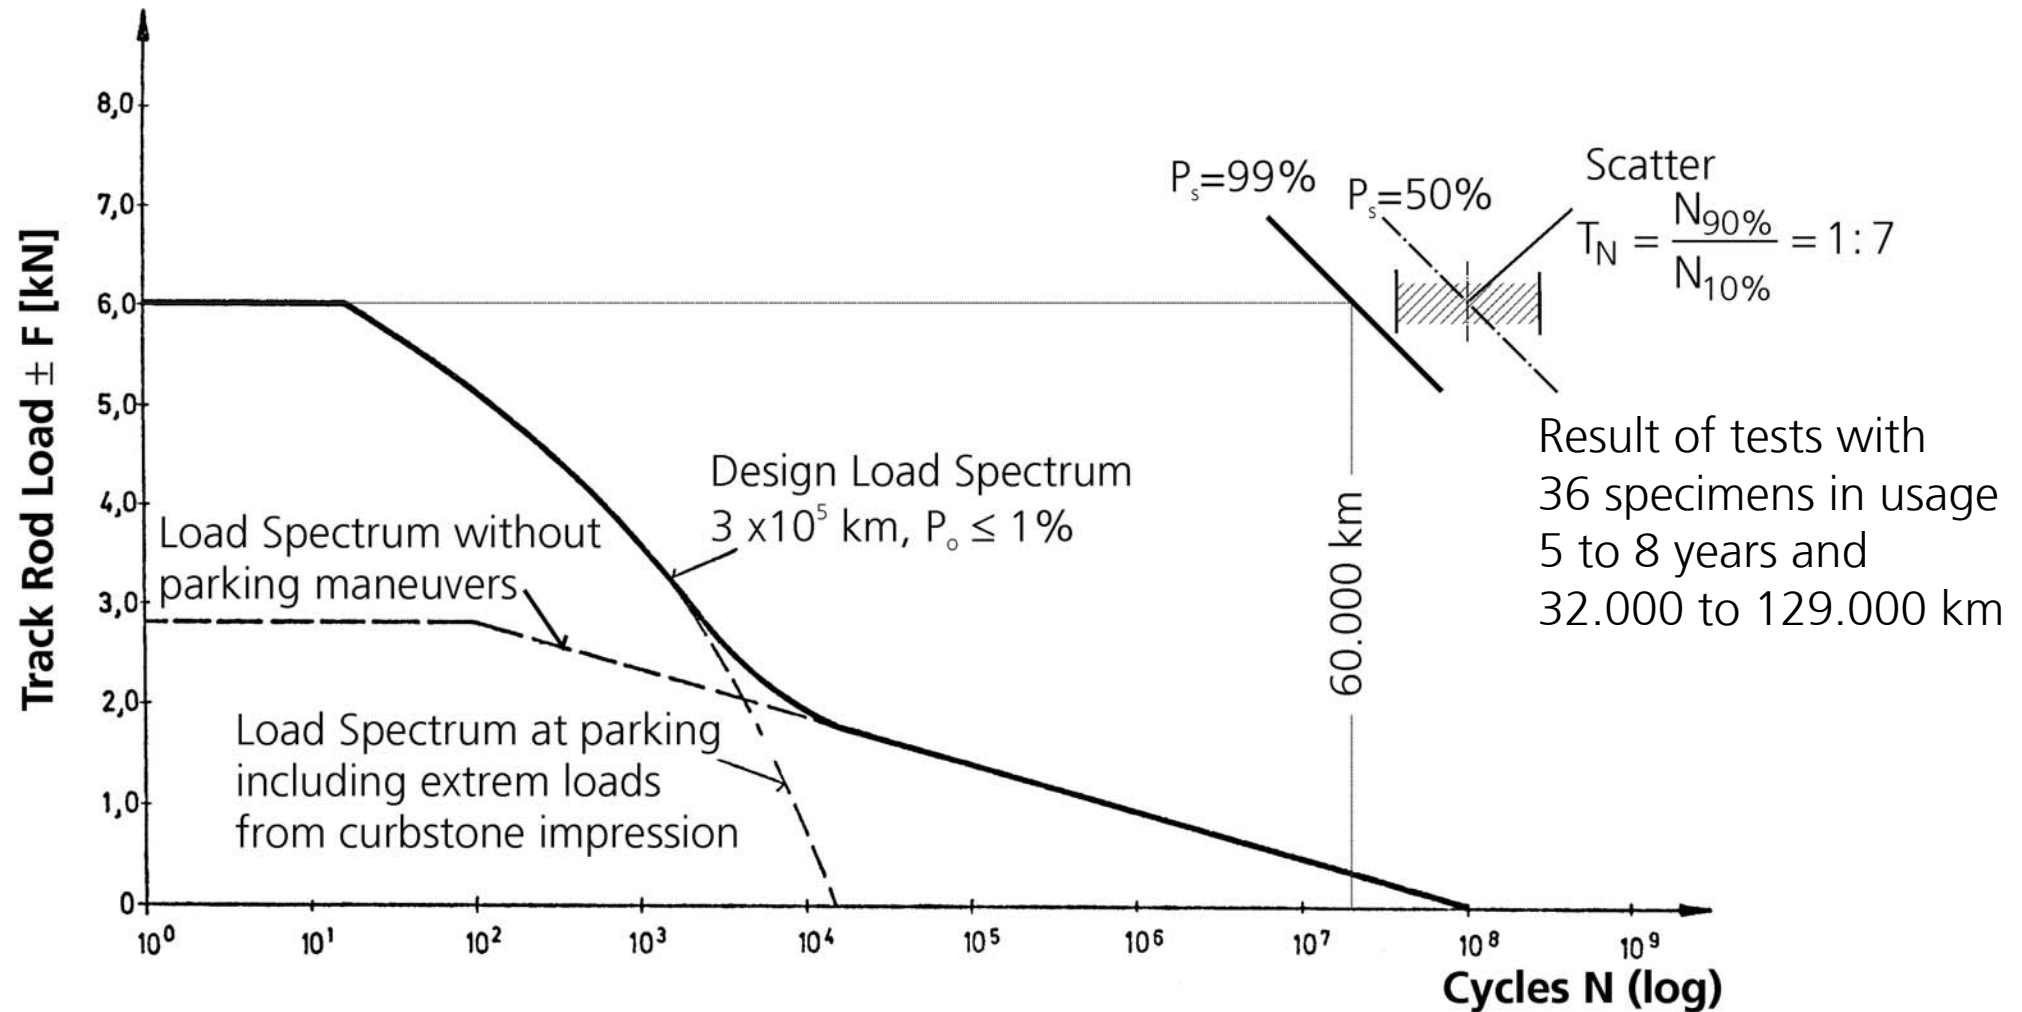
DIA 7339e

# Design Load Spectrum and Test Results with corroded Steering-Knuckle Arms
